## Asbestos Design Data Collection (DDC)

### Alexander McClure Elementary School (7380)

Address:	600 W. Hunting Park Avenue, Philadelphia, PA 19140	Total Material for Abatement (SF):	
Inspector Name/Company:	Synertech Incorporated	Total Material for Abatement (LF):	See Summary List Below
Date Inspected:	12/20/2019 – 1/06/2020	Requested by:	School District of Philadelphia Office of Environmental Services
Date Issued (within 24 hours):	1/06/2020

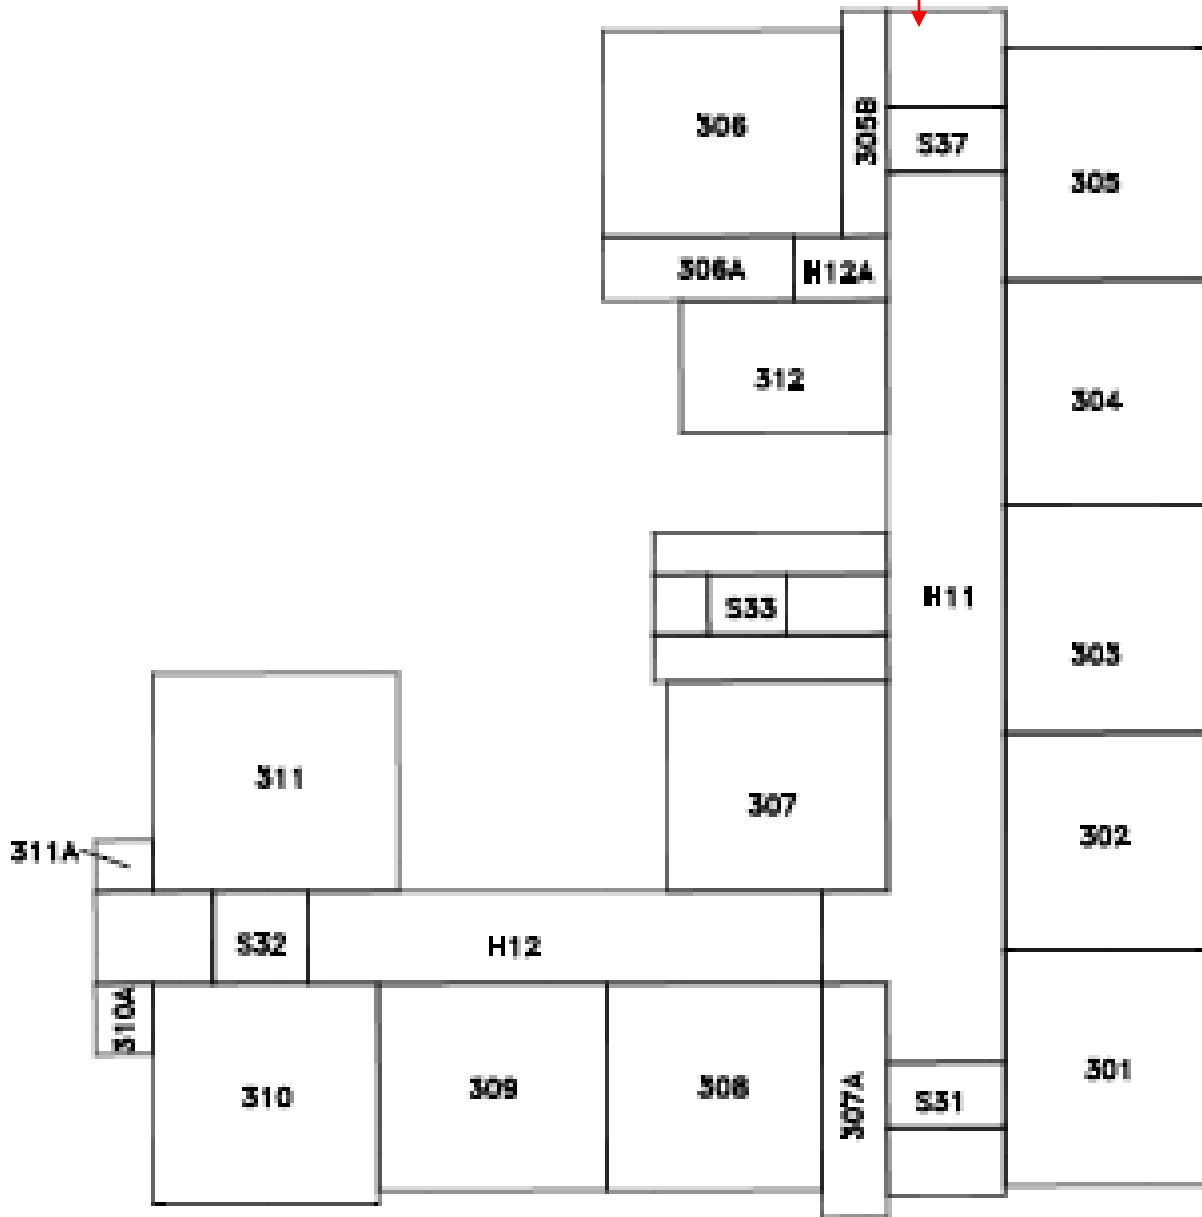
## Alexander McClure Elementary School (7380) 3<sup>rd</sup> Floor

Marshall Street Stairwell S37 2<sup>nd</sup> – 3<sup>rd</sup> floor landing –  
Remove 44 linear feet of pipe/pipe fitting insulation  
from 2 Risers

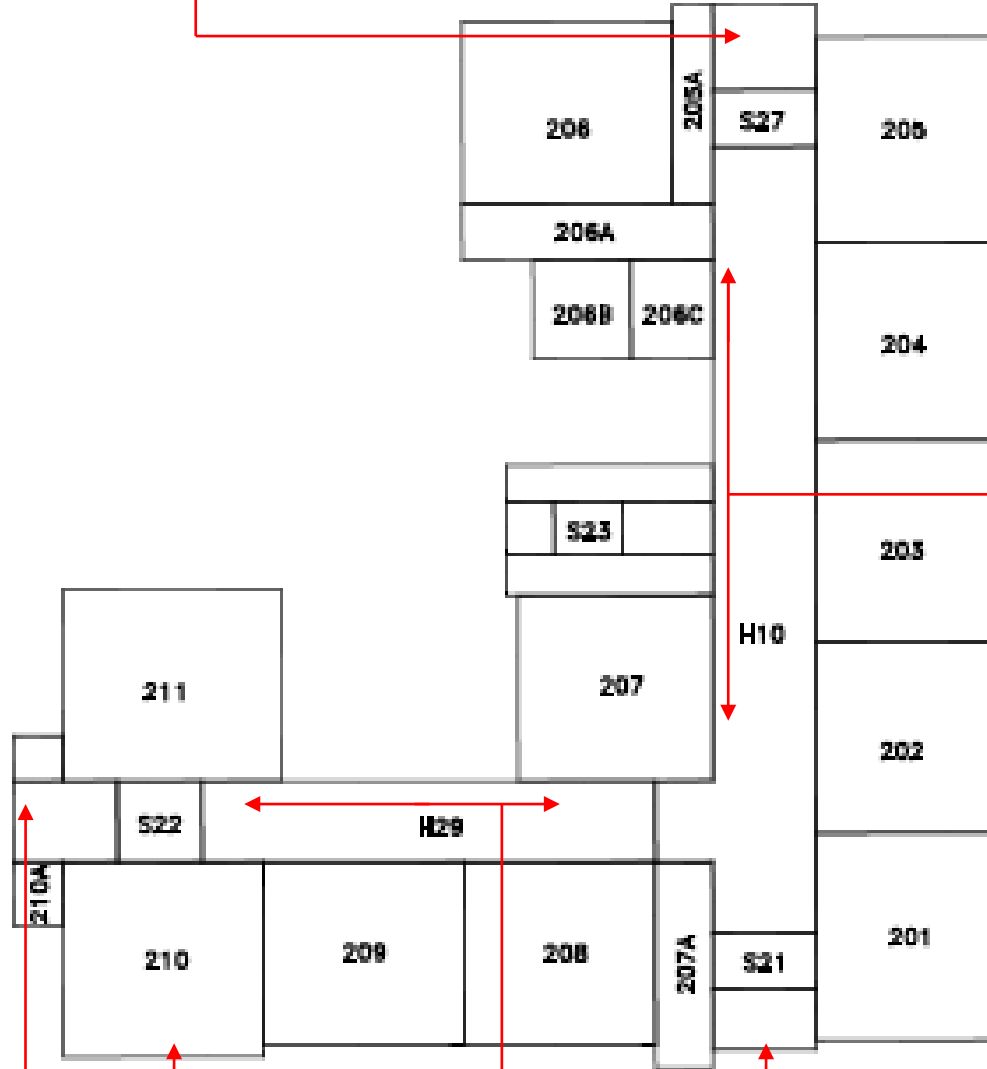
## Alexander McClure Elementary School (7380) 2<sup>nd</sup> Floor

Marshall Street Stairwell S27 1<sup>st</sup> - 2<sup>nd</sup> floor landing –  
 Remove 44 linear feet of pipe/pipe fitting insulation from 2 Risers

Hallway H10 - Remove 84 linear feet of pipe/pipe fitting insulation  
 from 4 Risers (including all insulation above suspended ceiling)

Rear Parking Stairwell S22 1<sup>st</sup>- 2<sup>nd</sup> floor landing –  
 Remove 44 linear feet of pipe/pipe fitting insulation  
 from 2 Risers

N. 6<sup>th</sup> Street Stairwell S21 1<sup>st</sup> – 2<sup>nd</sup> floor landing -  
 Remove 44 linear feet of pipe/pipe fitting insulation  
 from 2 Risers

Classroom 210 – Encapsulate 1 linear foot of pipe insulation

Hallway H29 - Remove 48 linear feet of pipe/pipe fitting insulation from  
 4 Risers (including all insulation above suspended ceiling)

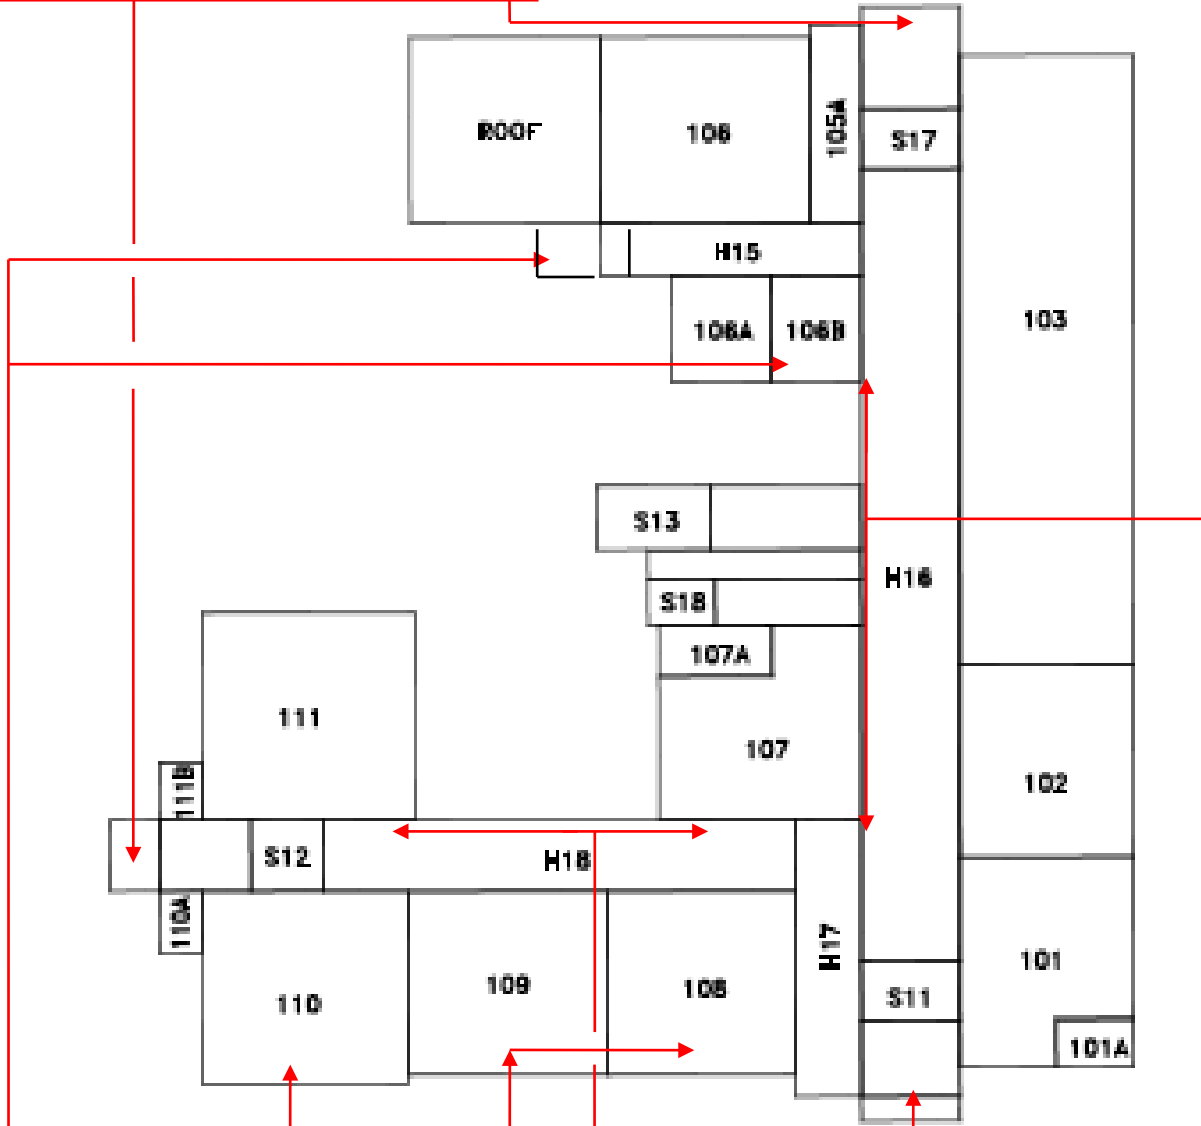
### 1<sup>st</sup> Floor

Hallway H16 - Remove 84 linear feet of pipe/pipe fitting insulation from 4 Risers (including all insulation above suspended ceiling)

Marshall Street Entrance Vestibule S17 and Rear Parking Lot Entrance Vestibule S12 – Remove all pipe/pipe fitting insulation from 2 Risers (50 and 34 respectively)

Classrooms 108, 109, 110, Main Office (106B), Office beside Copy Room (106C) – Encapsulate 1 linear foot of pipe/pipe fitting insulation

N. 6<sup>th</sup> Street Entrance Vestibule S11 – Remove 50 linear feet of pipe/pipe fitting insulation from 2 Risers

Hallway H18 - Remove 48 linear feet of pipe/pipe fitting insulation from 4 Risers (including all insulation above suspended ceiling)

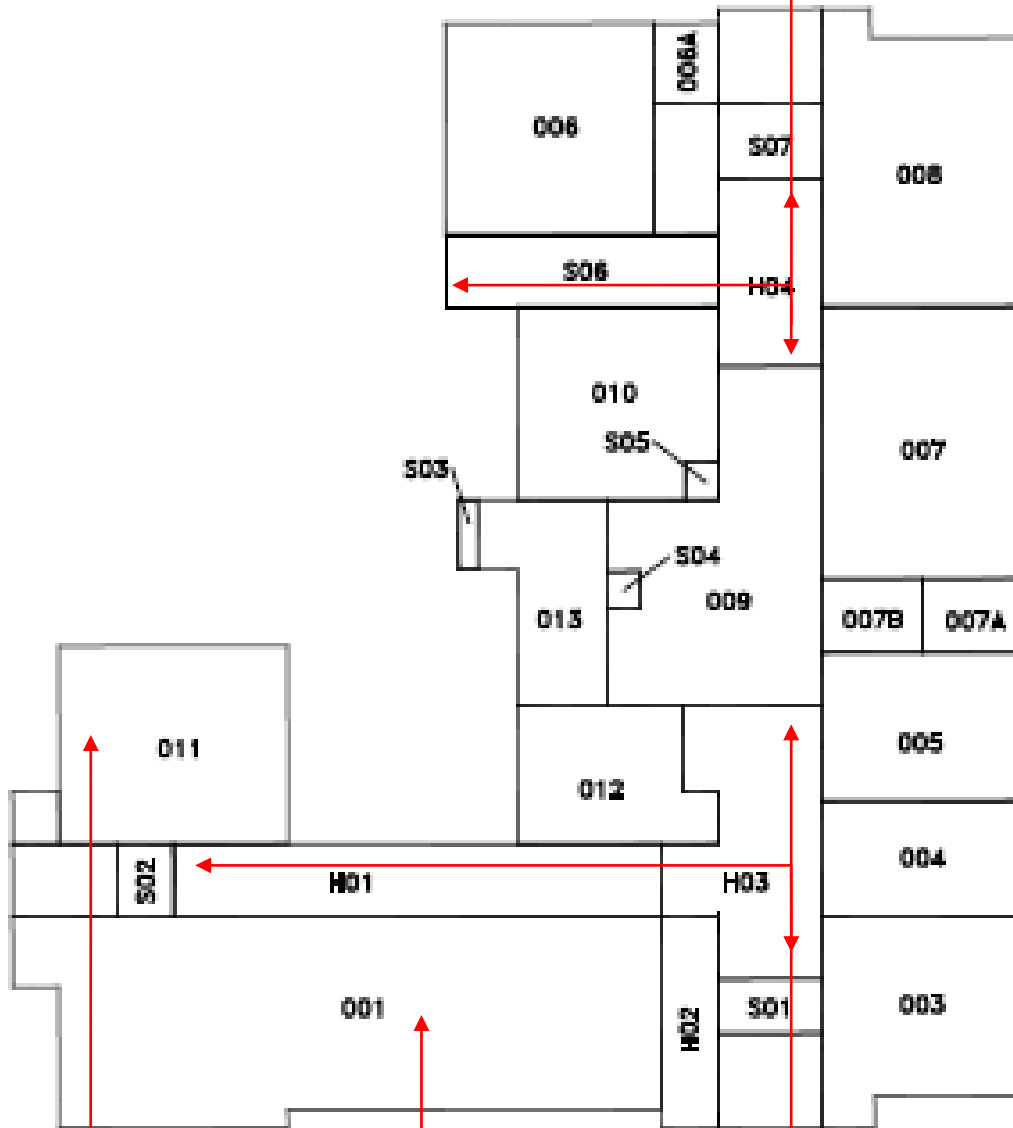
## Alexander McClure Elementary School (7380) Basement

Hallway H04 and S06 (1 Combined Work Area) -  
Remove 170 linear feet of pipe/pipe fitting insulation

Pre-K Classroom 011 and Pipe Chase - Remove  
278 linear feet of pipe/pipe fitting insulation

Hallway H01 and H03 (1 Combined Work Area) -  
Remove 350 linear feet of pipe/pipe fitting insulation

Gymnasium 001 and Pipe Chase - Remove  
502 linear feet of pipe/pipe fitting insulation
